**Sailboat Lohengrin Survey Report**

<b>SAIL BOAT</b>	Lohengrin
<b>HIN</b>	NA
<b>DATE</b>	13.06.23
<b>REPORT NO.</b>	10.2023.10-SIMS-09

<b>Report Completed By</b>	Mikhail Boev	<b>Date</b>	17.06.23
<b>Signature</b>	<i>MikrBoev</i>	<b>ID Number</b>	SIMS_001
<b>Company On Whose Behalf Inspection Carried Out</b>	Owner : Mr. John Doe		
<b>Report Summary Seen By</b>	Owner : Mr. John Doe	<b>Date</b>	17.06.23
<b>Place Of Survey</b>	Bronte Harbour Yacht Club, Oakville, On.		
<b>Type Of Survey</b>	Condition And Valuation Survey

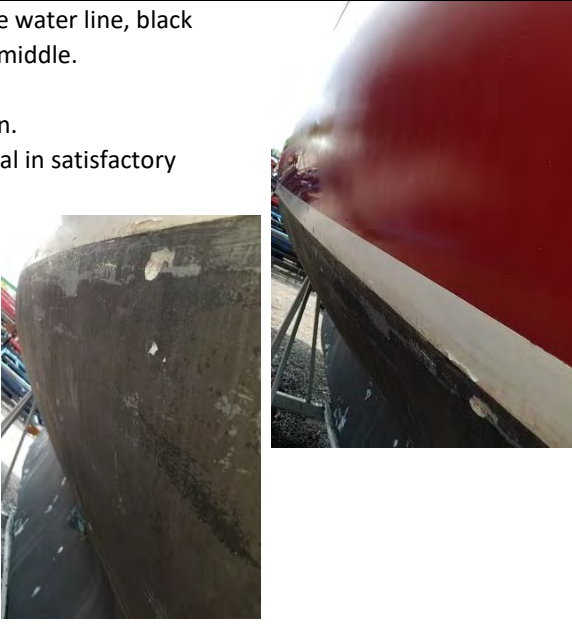
1.1	General Hull Condition	Yes	No	NA	NS
<p>Fiberglass mono long keel hull, Red gelcoat above water line, black antifouling below water line, with White stripe in middle.</p> <p>Antifouling below water line found in old condition.</p> <p>Hull shows in general high moisture levels, in general in satisfactory condition, no major damage seen.</p>		√

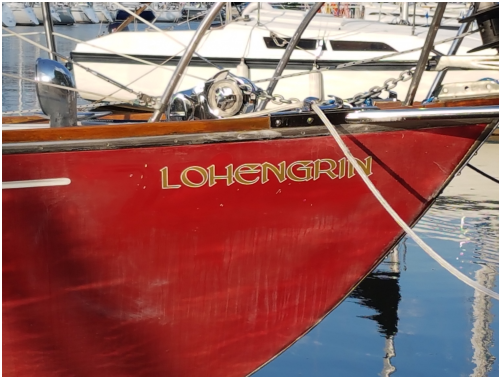
1.2	Bow / Stem	Yes	No	NA	NS
<p>Bow and stem found in satisfactory condition, no major damage seen.</p>		√

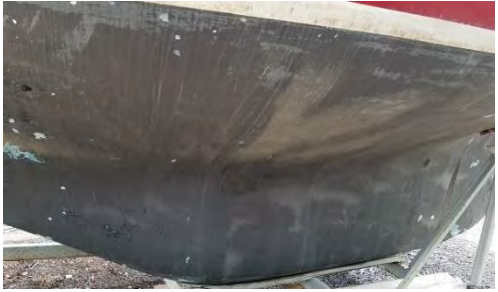
1.3	Keel	Yes √	No	NA	NS
	Long keel found in average condition

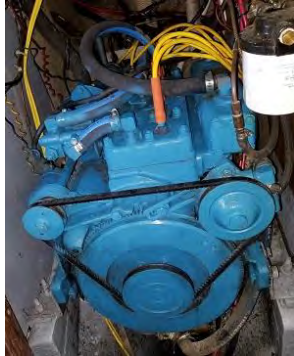
2.1	General Engine Condition	Yes	No	NA	NS
	<p>Gray Marine Sea Scout 4 cylinders, water cooled marine gasoline engine. Engine found in old condition, however no any signs of visual damage applies.</p>

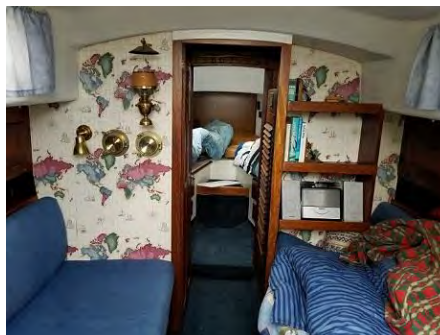
3.1	Interior	Yes	No	NA	NS
	<p>Traditional interior, found in satisfactory condition for the age of the vessel.</p> <p>Living space in midship, v berth cabin at forward compartment, with toilet at port side.</p> <p>Lockers, drawers and seats found satisfactory.</p>	√

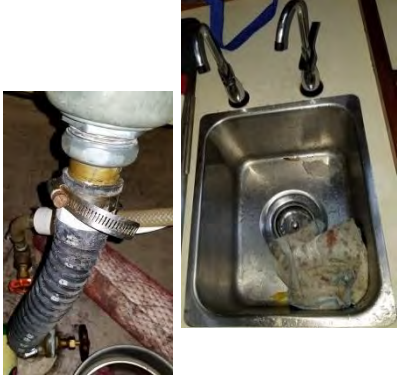
4.3	Sink / Faucets	Yes ✓	No	NA	NS
Stainless steel sink and faucet. Water and drain lines checked, found in good condition.

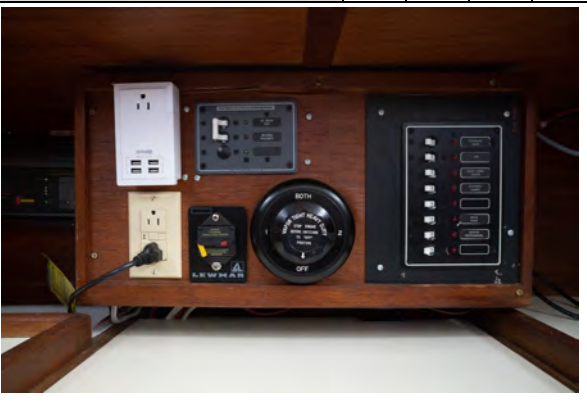
6.1	AC Power System	Yes √	No	NA	NS
AC power system through shore power line.					
6.2	DC Power System	Yes √	No	NA	NS
12V DC power system through battery bank. DC fuse panel with switches.

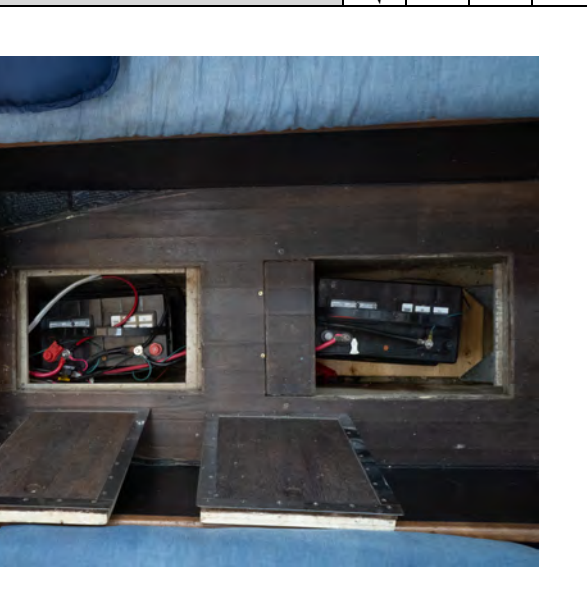
6.3	Batteries Storage / Stowage / Securing / Ventilation / Terminal Protection	Yes √	No	NA	NS
2 batteries connected in parallel.

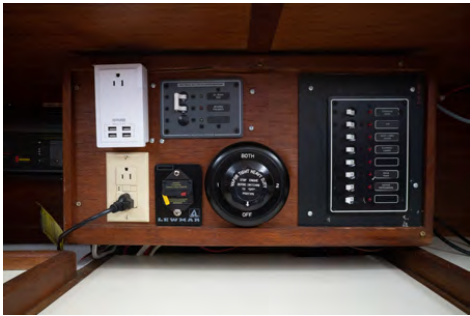
GFCI electrical outlet at galley space.

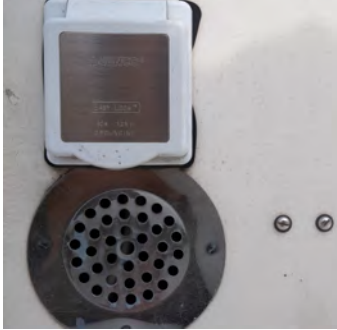
125V, 30 AMP shore power plug, found weather proofed.

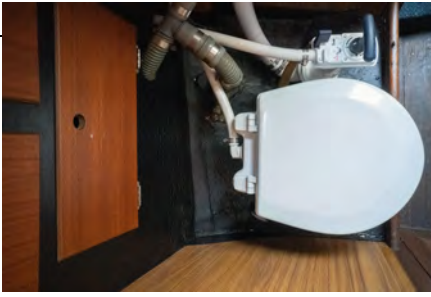
8.1	Toilet	Yes	No ✓	NA	NS
<p>Manual flush marine toilet.  <u>Sewage system, waste line found connected to bypass Y valve. line to waste holding tank and other overboard line.</u></p>

S.	Non Conformances & Remarks	Category	Recommendations
1	Sewage system, waste line found connected to bypass Y valve with one end to overboard.	High	To cancel the bypass valve and line and block the overboard discharge valve as per Transport Canada requirement.
2	Ball valve seacock in engine compartment found frozen, not turning.	Low	To apply proper maintenance accordingly.
3	Exhaust line found not double clamped.	Medium	Every exhaust system fitting, joint, clamp, and support shall be accessible. All hose connections shall be double clamped.
4	Metal fuel tank found to be not grounded.	Low	To connect ground line to fuel tank accordingly.
5	No safety caps apply on batteries positive terminals	Medium	To install safety caps on batteries positive terminals as per <b>ABYC E-10.7.7.1</b>
6	Batteries are not installed in proper acid proof tray	Medium	To secure batteries in acid proof trays as per <b>ABYC E-10.7.7.1</b>

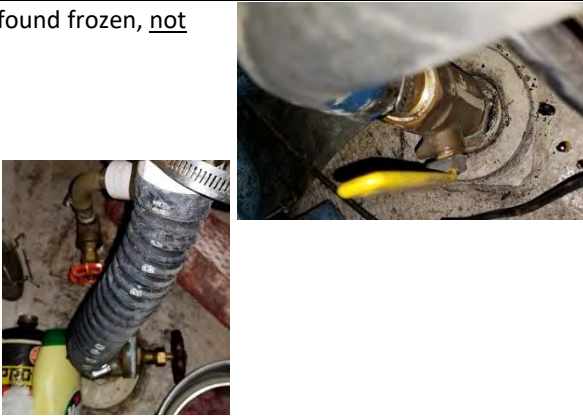
8.4	Seacocks	Yes ✓	No	NA	NS
<p>Brass ball valve seacock in engine compartment found frozen, <u>not turning.</u></p> <p>2 Ball valve seacocks below galley space found satisfactory.</p>

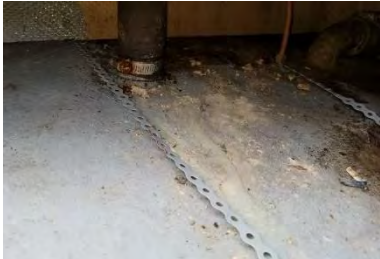
9.3	Holding Tank	Yes	No	NA	NS
	<p>Waste holding tank checked found satisfactory.            Fittings in good condition.  <u>Waste suction line found cracked.</u></p>		✓

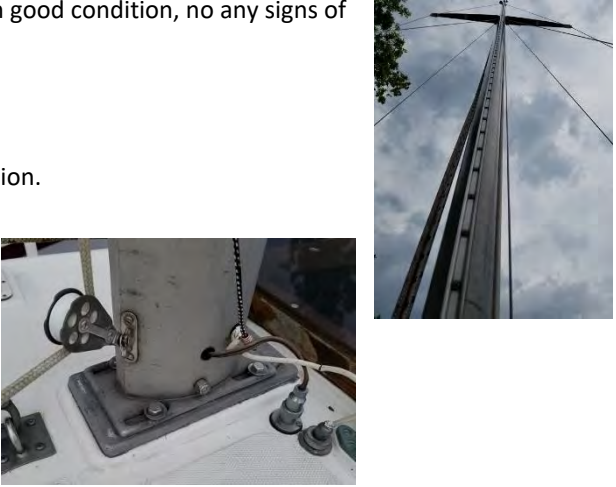
11.1	Masts / Mast Step	Yes √	No	NA	NS
<p>Aluminum mast seen from deck level, found in good condition, no any signs of corrosion or cracks applies.</p> <p>Mast step on deck found solid, in good condition.</p>

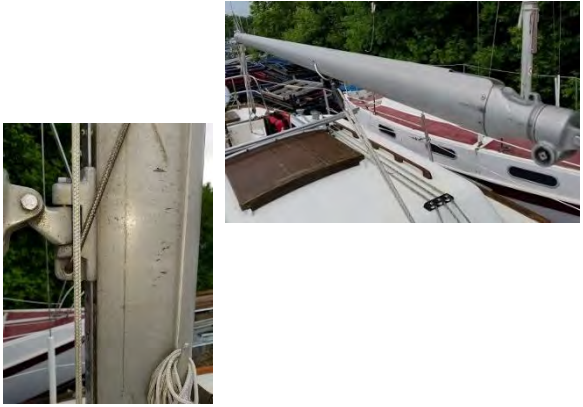
11.2	Booms Gooseneck	Yes √	No	NA	NS
<p>Aluminum boom found in good condition. Goose neck, no any rust or corrosion.</p>

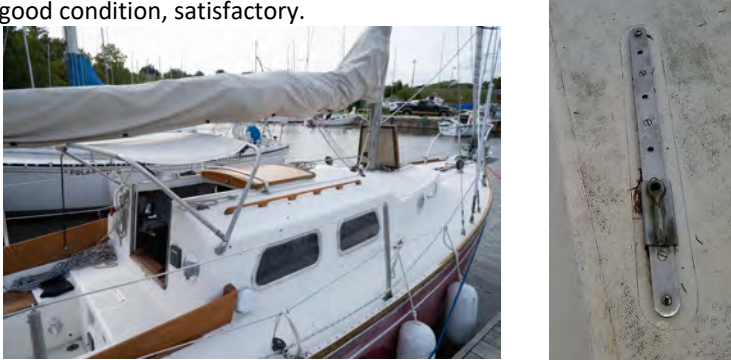
11.3	Chain plates	Yes √	No	NA	NS
<p>Stainless steel chain plates found in good condition, satisfactory.</p>
